**DEPARTMENT OF TRANSPORTATION****DIVISION OF ENGINEERING SERVICES**

Contract #: 04-0120F4Cty: SF/ALA Rte: 80 PM: 13.2/13.9File #: 69.15**SOURCE INSPECTION REPORT****Resident Engineer:** Pursell, Gary**Address:** 333 Burma Road**City:** Oakland, CA 94607**Report No:** SIR-000628**Date Inspected:** 17-May-2009**Project Name:** SAS Superstructure**OSM Arrival Time:** 0**Prime Contractor:** American Bridge/Fluor Enterprises, a JV**OSM Departure Time:** 12**Contractor:** Zhenhua Port Machinery Company, Ltd (ZPMC), Changxing Island **Location:** Changxing Dao, Shanghai

**Other:** Surface Preparation and Coatings Application**Bridge No:** 34-0006**Component:** OBG 1AE, 5BE, Tower L1E, Misc. Metal**Bid Item:** 77,78,79,80**Lot No:** B226**Summary of Items Observed:**

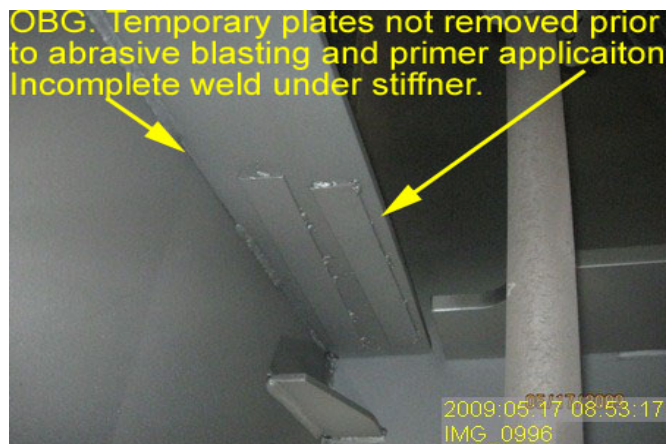
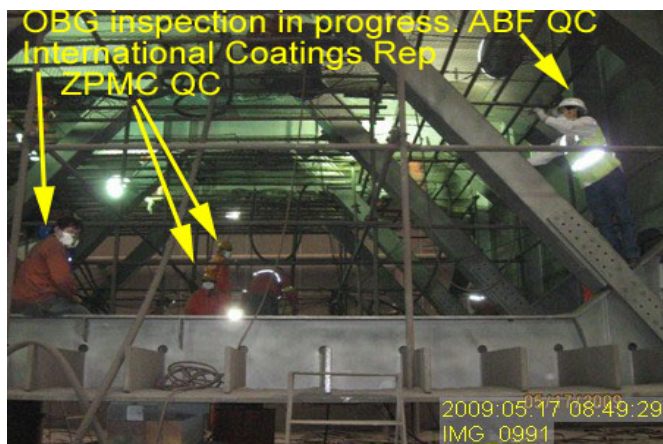
Fabrication on assembled components of the OBG's are not complete. Coating damage requiring re-blast is expected.
